# Manhole Inspection Summary

Manhole # S43GG\_037MH

Insp Date: **6/9/09 3:13 PM**

**Location** Address: **1602 PRESTON ST (REAR ON ELLSWORTH ST)**

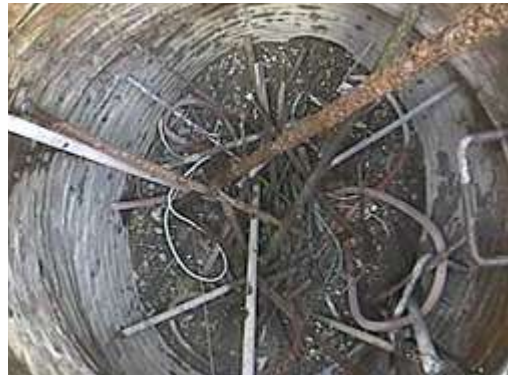
Top View

Condition: ☐ Sound ☐ Cracked ☐ Root Intrusion ☐ Deteriorated ☐ Leaks ☒ **Debris**

debris

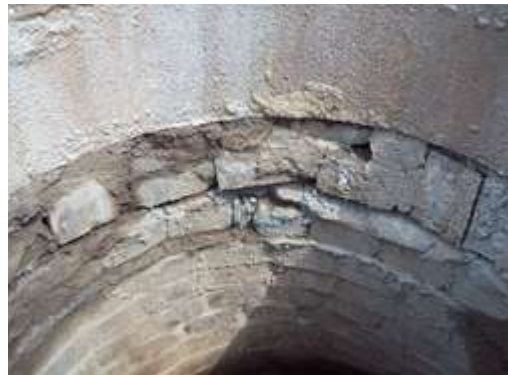
Defect 2

Condition: ☐ Sound ☐ Cracked ☐ Root Intrusion ☐ Loose Brick ☒ **Deteriorated**

Deteriorated chimney

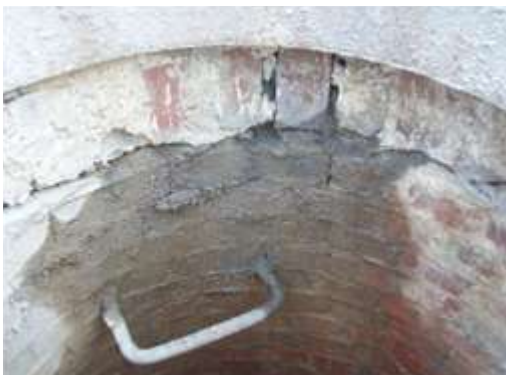
Defect 1

Infiltration: ☐ None ☒ **Joint** ☐ Cracks ☐ Mortar ☐ Roots ☐ Wall

Infiltration @ joint

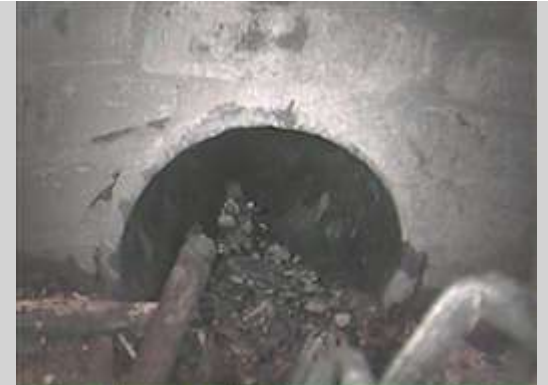
12 O'Clock Outflow

Deposits: ☐ None ☐ Mud ☐ Sludge ☒ **Debris** ☐ Grease

Silt Depth: **0** (in.) Deposits Extent: **Light**
